THE GROWTH OF METAL WHISKERS ON ELECTRICAL COMPONENTS

S. M. Arnold
Bell Telephone Laboratories, Inc.
Murray Hill, New Jersey

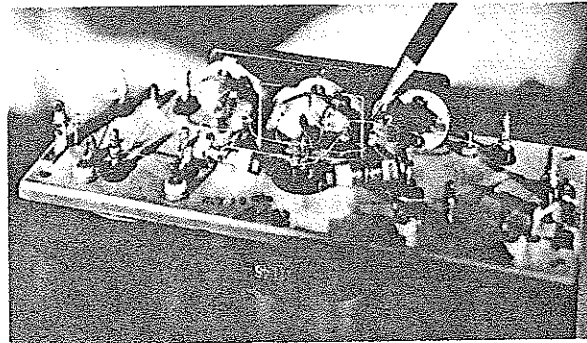
Of interest because it was the first part of the telephone plant in which growths of conducting filaments are known to have caused electrical failure, is the channel frequency filter shown in Fig. 1. In this unit, essential for the simultaneous transmission of a number of conversations over a multi-channel telephone line, whiskers developed on zinc-plated brackets and bridged across to nearby air capacitors, as shown in Fig. 2. Approximately one year was required from

Fig. 1. Channel frequency filter. Pencil indicates spacing bridged by whiskers.

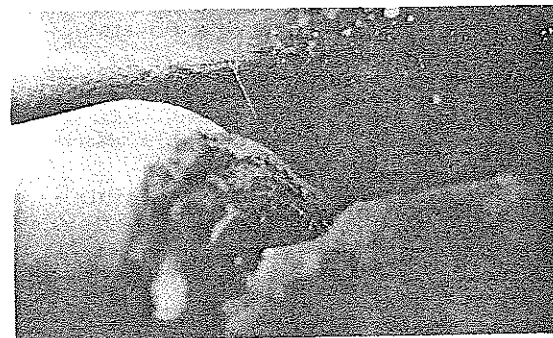
Fig. 2. Zinc whiskers responsible for low impedance in channel filter. Spacing bridged approximately $3/16$ in.

the time of assembly until a low impedance condition developed as a result of whiskers spanning this 3/16 in. spacing.

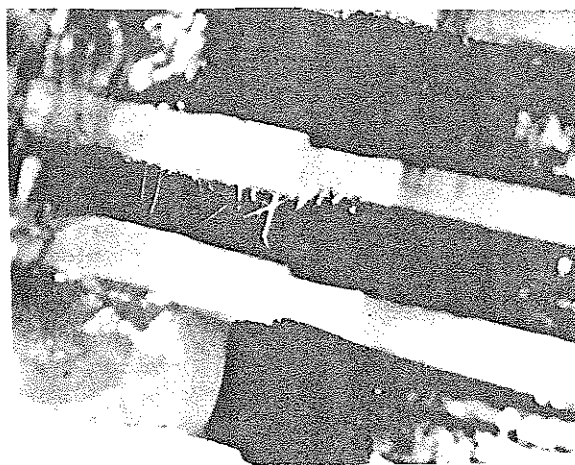
A copper oxide rectifier destined for military use failed in preservice trials because of the growth of metal whiskers. Figure 3 is an enlarged view of a portion of the rectifier.* The whiskers can be seen bridging between the tin coated terminals, short circuiting the unit. Because it had been enclosed, the actual trouble was found only after the unit had been dismantled, an operation not always possible or desirable under field conditions.

Fig. 3. Tin whiskers growth in trouble area of a copper oxide rectifier (18X).

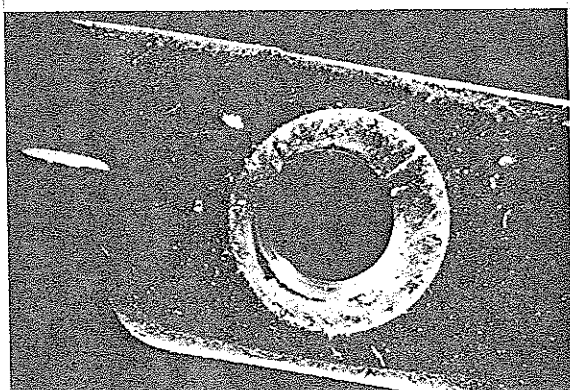
In Fig. 4 is shown a part of a protector mounting which failed because of whisker growth. In the assembly of this particular mounting, a clamping screw passes through a cylindrical bushing and forces the end of the bushing into close contact with a plated terminal lug.

This is an example of a situation in which the likelihood of trouble due to whiskers is enhanced by assembly requirements. It is believed that whisker growth is a result of stress. Further, it has been shown that pressure accelerates the growth of whiskers. (1) In the pileup in question, compression stresses are exerted by the clamping screws and a high pressure is developed at the edge of the bushing where it bears against the terminal face. There is sufficient space at the side of the bushing for whiskers developing in the highly stressed area to pass through to the adjacent terminal and establish a low impedance path. In Fig. 4 can be seen a few of the relatively long whiskers which developed at the edge of the high pressure area immediately adjacent to the rim of the bushing. Also, there are present a few of the shorter whiskers characteristic of those observed on other parts of the surface outside of the pressure area.

Fig. 4. Protector mounting terminal. Tin whiskers in high pressure area (15X).

may be anticipated on a tin-coated surface, for instance, where it is subjected to a high bearing pressure from another member. A barrier may be required between closely spaced circuit elements in such an area if high static stresses cannot be avoided.

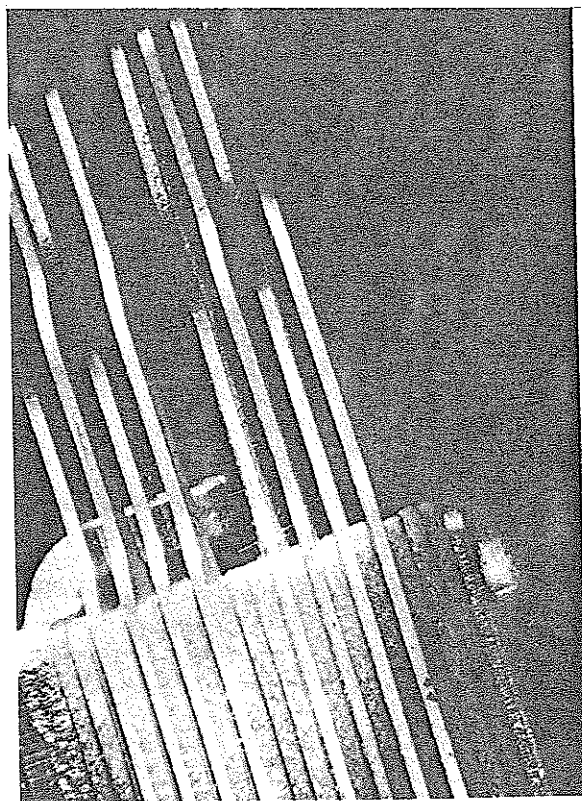
The terminal strip is a frequently used component in a wide variety of equipment. It is available in many forms, but often consists essentially of a series of closely spaced metal fingers or lugs protruding from a strip of insulating material. A hot-dipped or electroplated coating of tin or tin-lead is usually applied to insure ease in making soldered joints. In Fig. 5 an enlarged view of a portion of a unit with tin-plated terminals makes clear the reason occasional failures are encountered.

Fig. 5. Tin whiskers on individual members of terminal strip (4X).

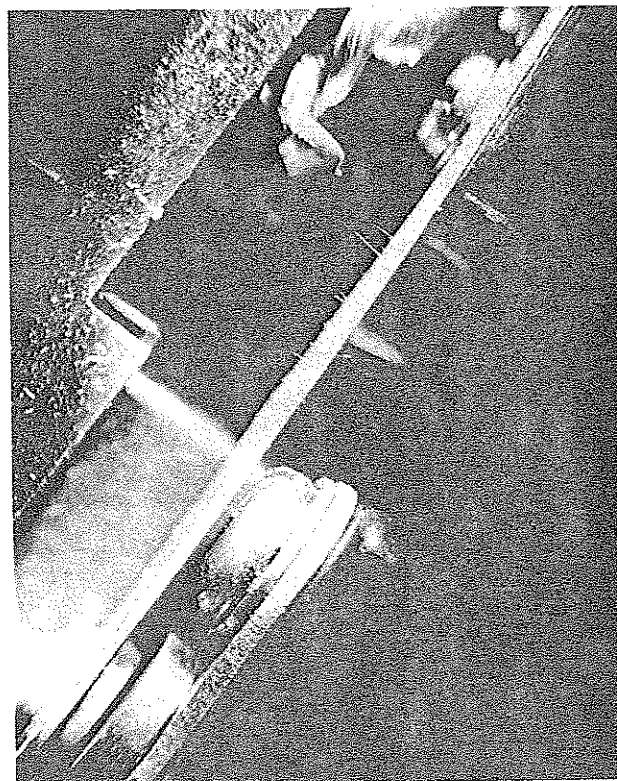
return spring. In Fig. 6 is shown a relay contact spring and some of the whiskers responsible for a grounded circuit. Figure 7 shows how whiskers grew on one of the compression plates of a relay and came into contact with an adjacent spring. This situation is similar to that described in the discussion of the short-circuited protector mounting where stress accelerated whisker growth.

Fig. 6. Whiskers on tin-plated relay contact spring (12X).

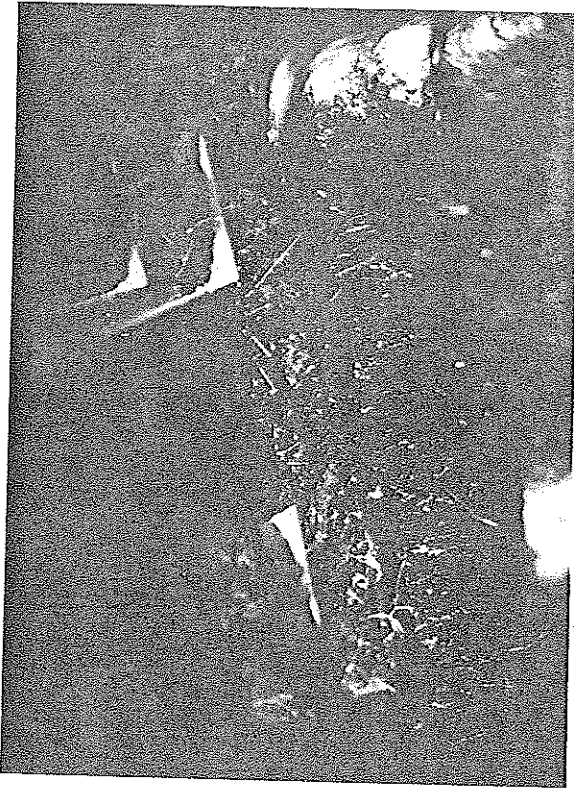
Fig. 7. Tin whiskers along edge of high-pressure area spring pile-up area of relay (15X).

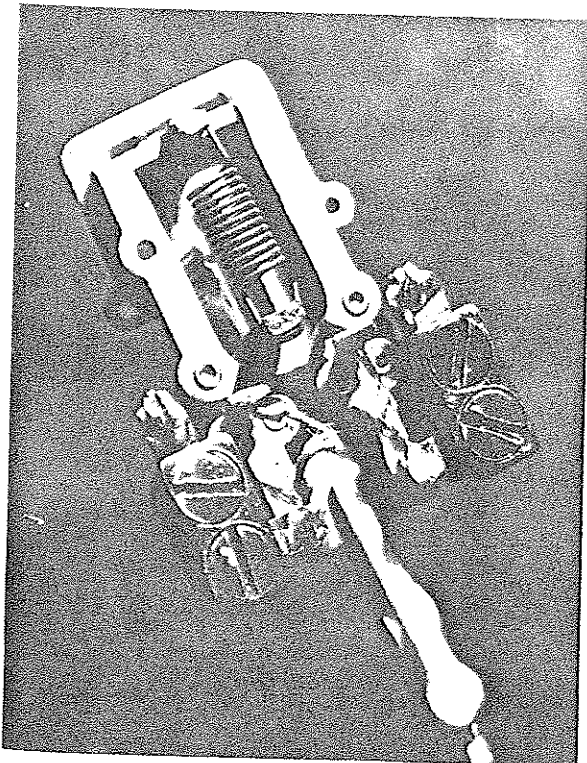
A relay armature return spring, electroplated with cadmium, is shown in Figs. 8 and 9. An appreciable growth of whiskers, some of them quite long, has taken place. Here, of course, they will cause no trouble as long as none becomes lodged at some vulnerable area.

Fig. 8. Small relay (1.5X).

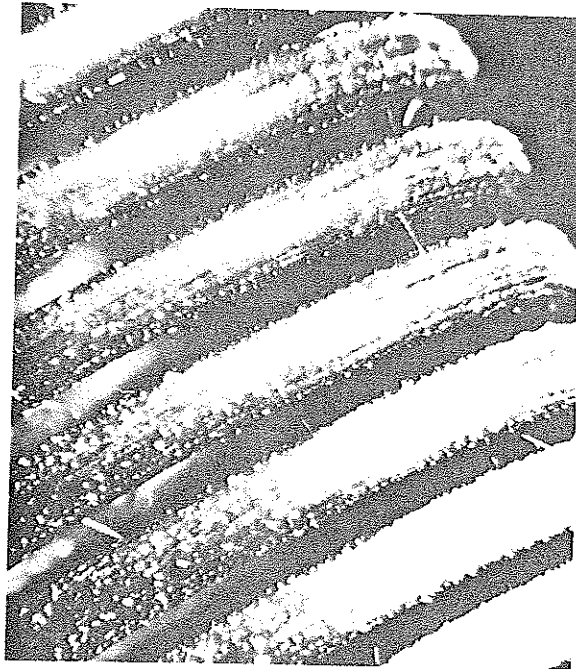
Fig. 9. Whiskers on cadmium plated armature return spring of relay shown in previous figure (30X).

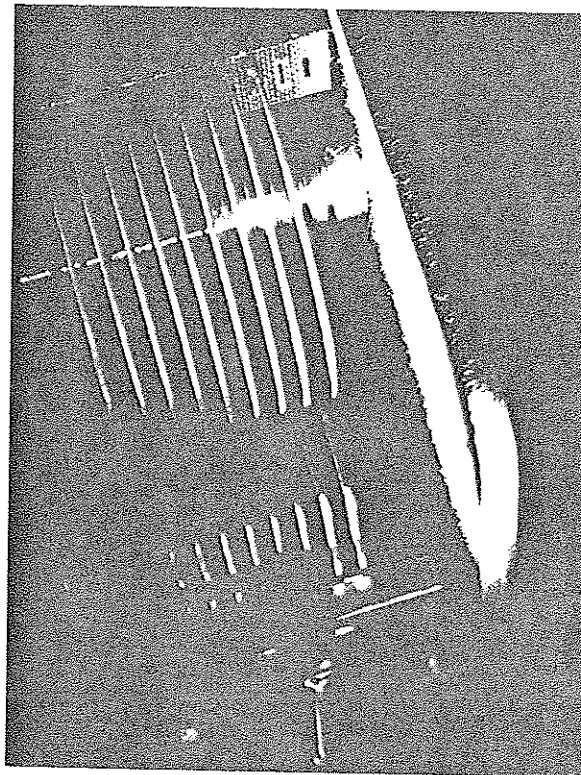
Fig. 10. Heavy growth of whiskers on end plate of variable air capacitor (3X).

fabrication of these capacitors, both brass and steel are used and may be left unfinished or coated with cadmium or zinc. A portion of one such variable capacitor with a fuzz of whiskers on the plated end piece is shown in Fig. 10. In Fig. 11 can be seen the whisker growths which led to failure when contact was made with an adjacent plate.

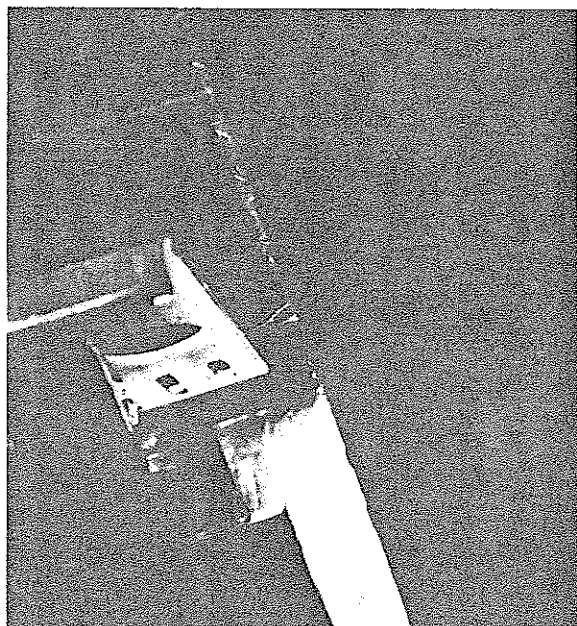
Fig. 11. Whiskers short-circuiting capacitor shown in previous figure (6X).

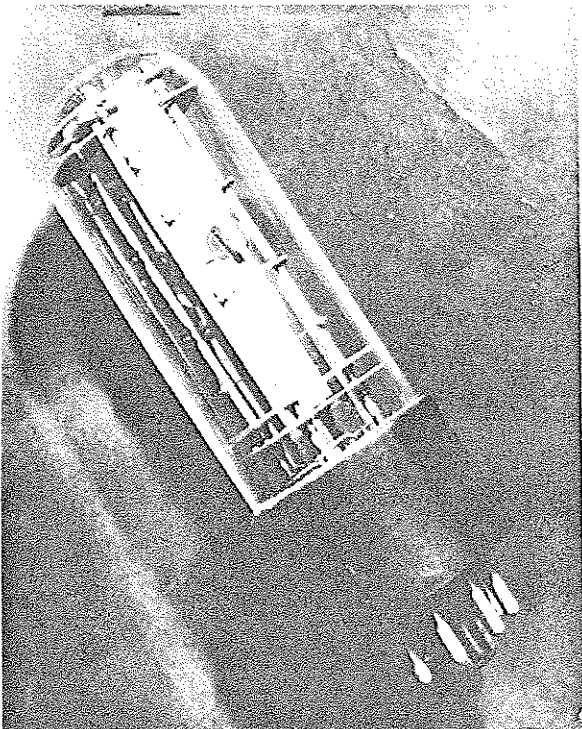
Evacuation or maintenance in an atmosphere of inert gas will not prevent the development of whiskers on a component. In Fig. 12 is shown an evacuated glass-enclosed quartz crystal resonator. Whiskers which grew on the crystal tin-plated support wires are clearly visible in Fig. 13. Similar growths have been observed in other

Fig. 12. Glass-enclosed quartz crystal resonator (1.5X).

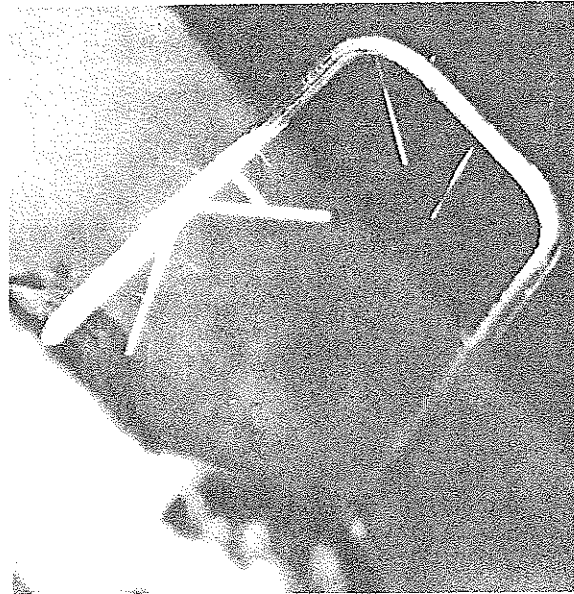
Fig. 13. Tin whiskers growth on support wires in resonator (18X).

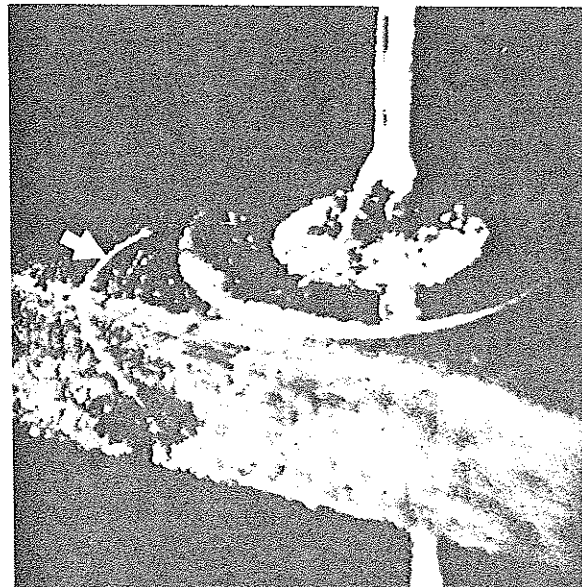
Fig. 14. Whiskers growth on solder fillet in resonator (48X).

units maintained under nitrogen at low pressure. The solder fillet at the attachment area of the crystal in one of these units is shown in Fig. 14. Whiskers have developed on the solder to a length sufficient to reach the edge of the quartz, made contact with similar whiskers growing from the fillet on the opposite face, and short circuit the unit.

instance the high-frequency vibration of the piezoelectric quartz produced stresses in the solder joint and initiated whisker growth. Laboratory studies of identical units have shown whisker growth only at the joint of crystals being vibrated.

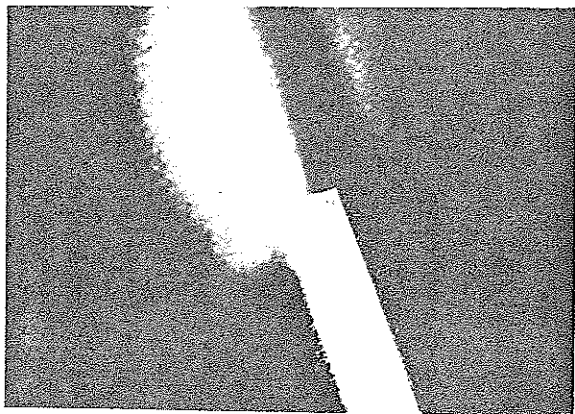
Immersion of a component part in oil also has been suggested as a means of preventing the formation of whiskers. Figure 15, however, shows that a tin-coated bracket immersed in a medium viscosity hydrocarbon oil immediately after it was electroplated is covered with a substantial growth of whiskers.

Fig. 15. Whiskers growth from tin-plated part submerged in oil (12X).
