## Tin Whiskers Growing Inside ~45 Year Old AF114 Germanium Transistors

Parts Analysis by: Chris Greenwell/QSS Group, Inc.

November 2005

NASA Electronic Parts and  
Packaging (NEPP) Program

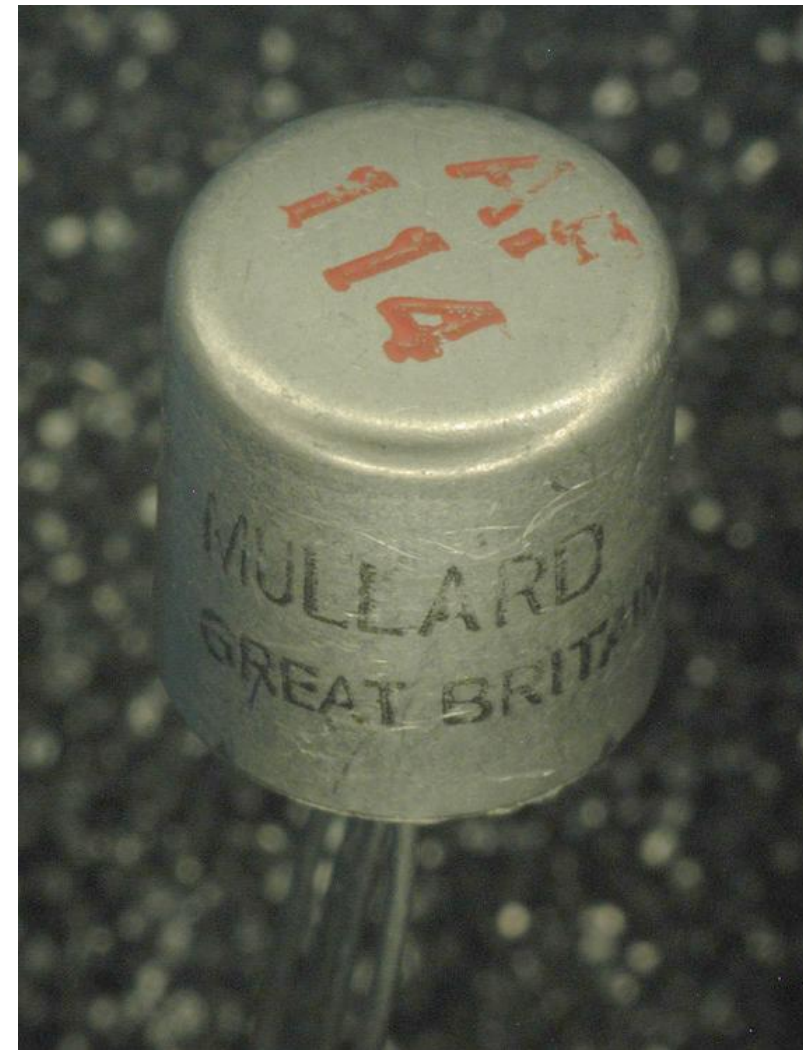
# External Photographs – AF114

No Lot Date Code Information Marked on Devices  
Based on Input from Source Assume parts made circa 1960

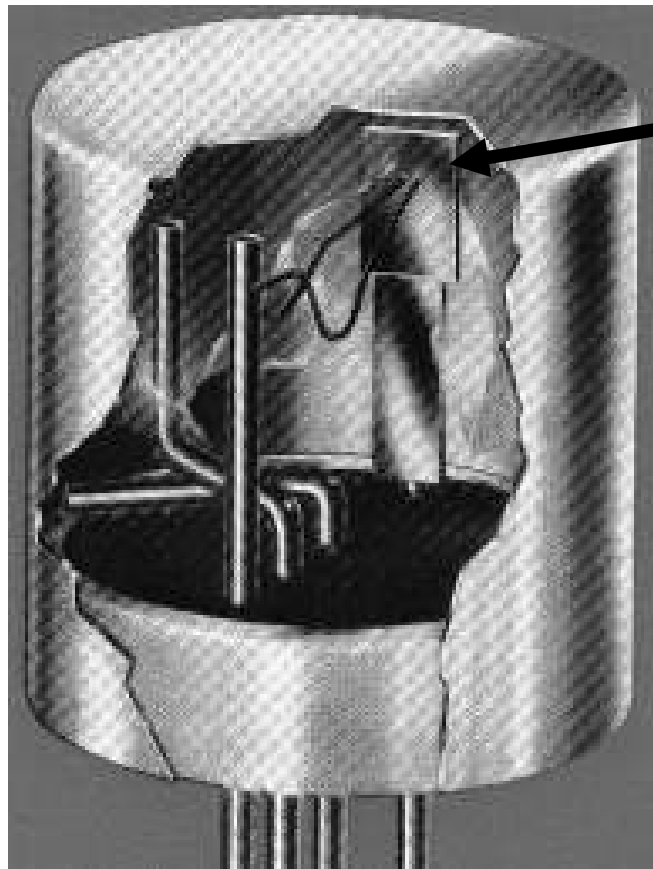
# Internal Diagram & X-Ray of AF114

**Note that Pin 3 is connected to the case,  
but is not connected to the transistor (pins 1, 2 and 4)  
Pin 1 = Emitter, 2 = Base, 3 = Case, 4 = Collector**

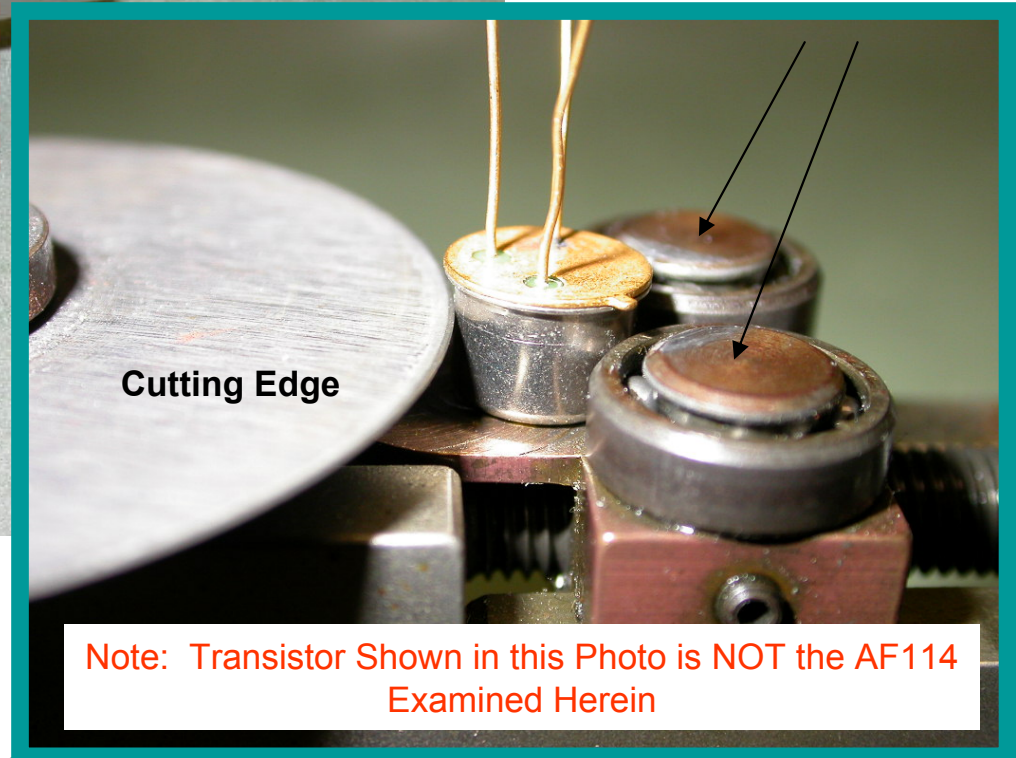
# “Can Opener”

Photos to Illustrate type of Tool Used to Open the Transistor Package

Pivoting this Handle Rotates the Device Package Against the Cutting Edge

Roller Bearings

Cutting Edge

Note: Transistor Shown in this Photo is NOT the AF114 Examined Herein

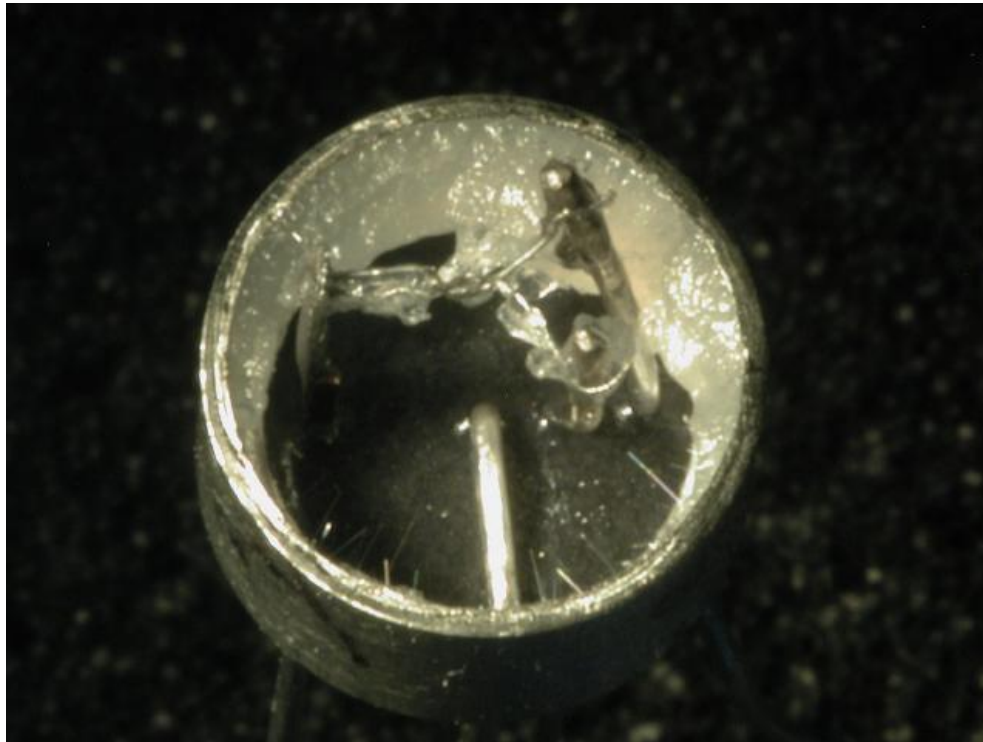
# Internal Optical Microscopy of AF114 after Opening TO Package

Inside of Transistor with Top Removed  
Whiskers are already evident

Top of Case contains  
Jelly-Like Substance  
(similar to petroleum jelly in viscosity,  
Suspected to be some type of Silicone)

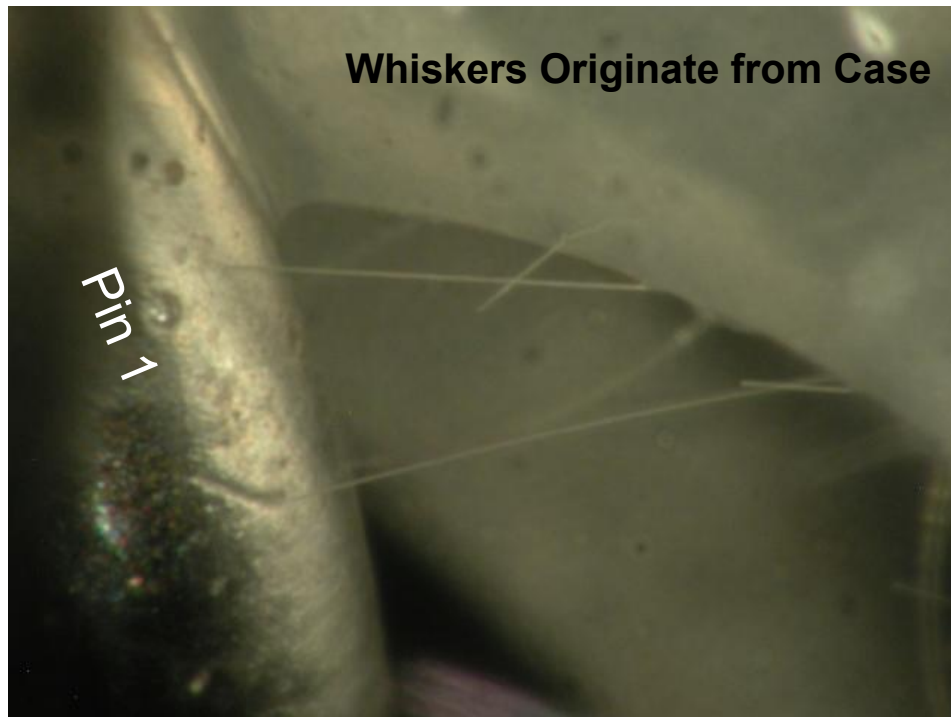
Whiskers Shorting from Case to Pin 1

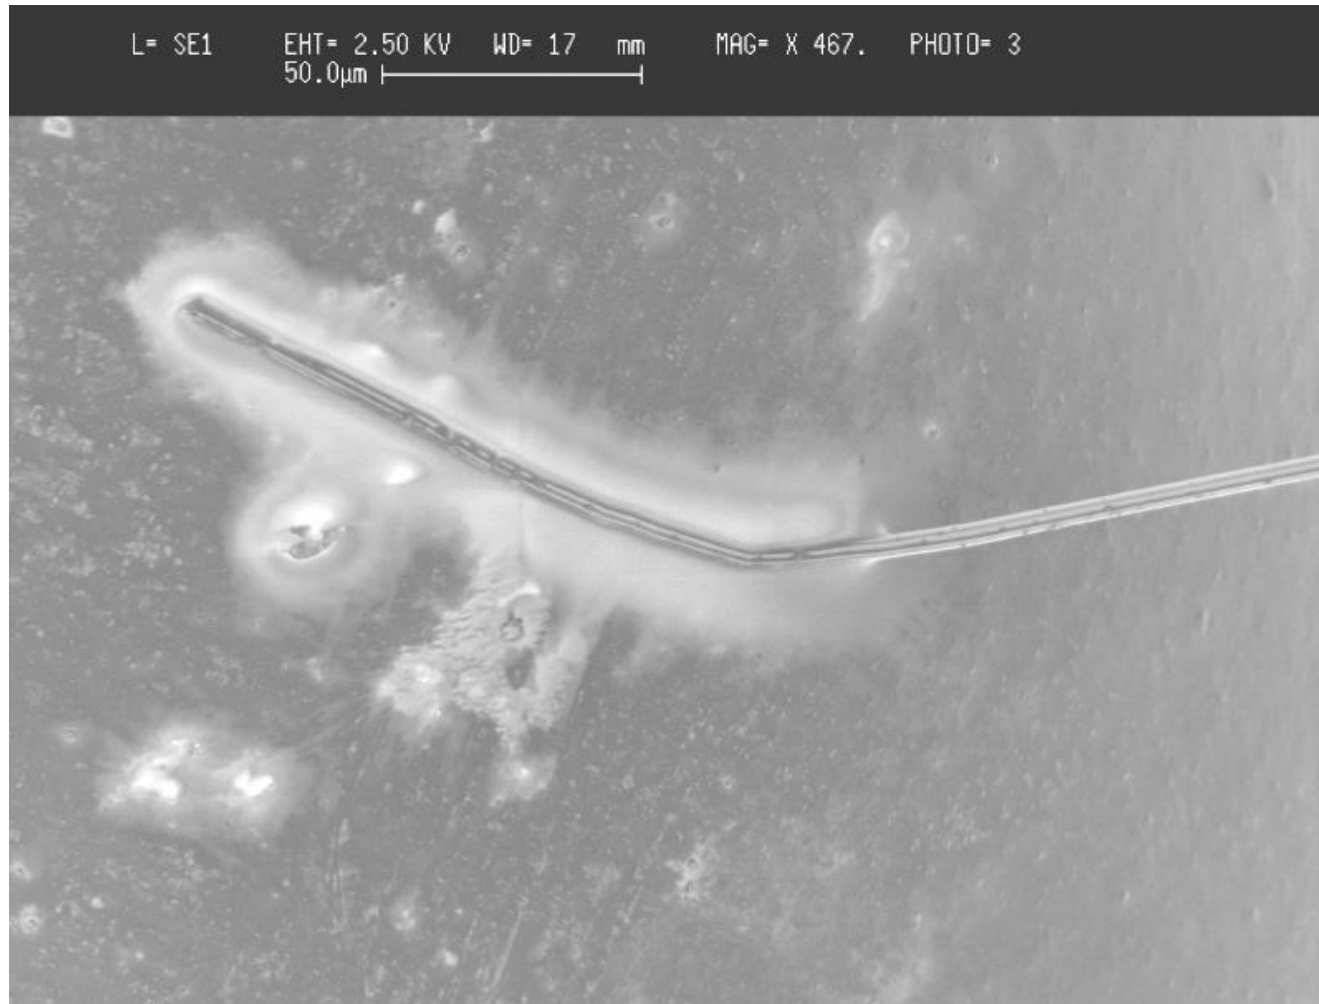
## *Whisker Shorting to Pin 1*

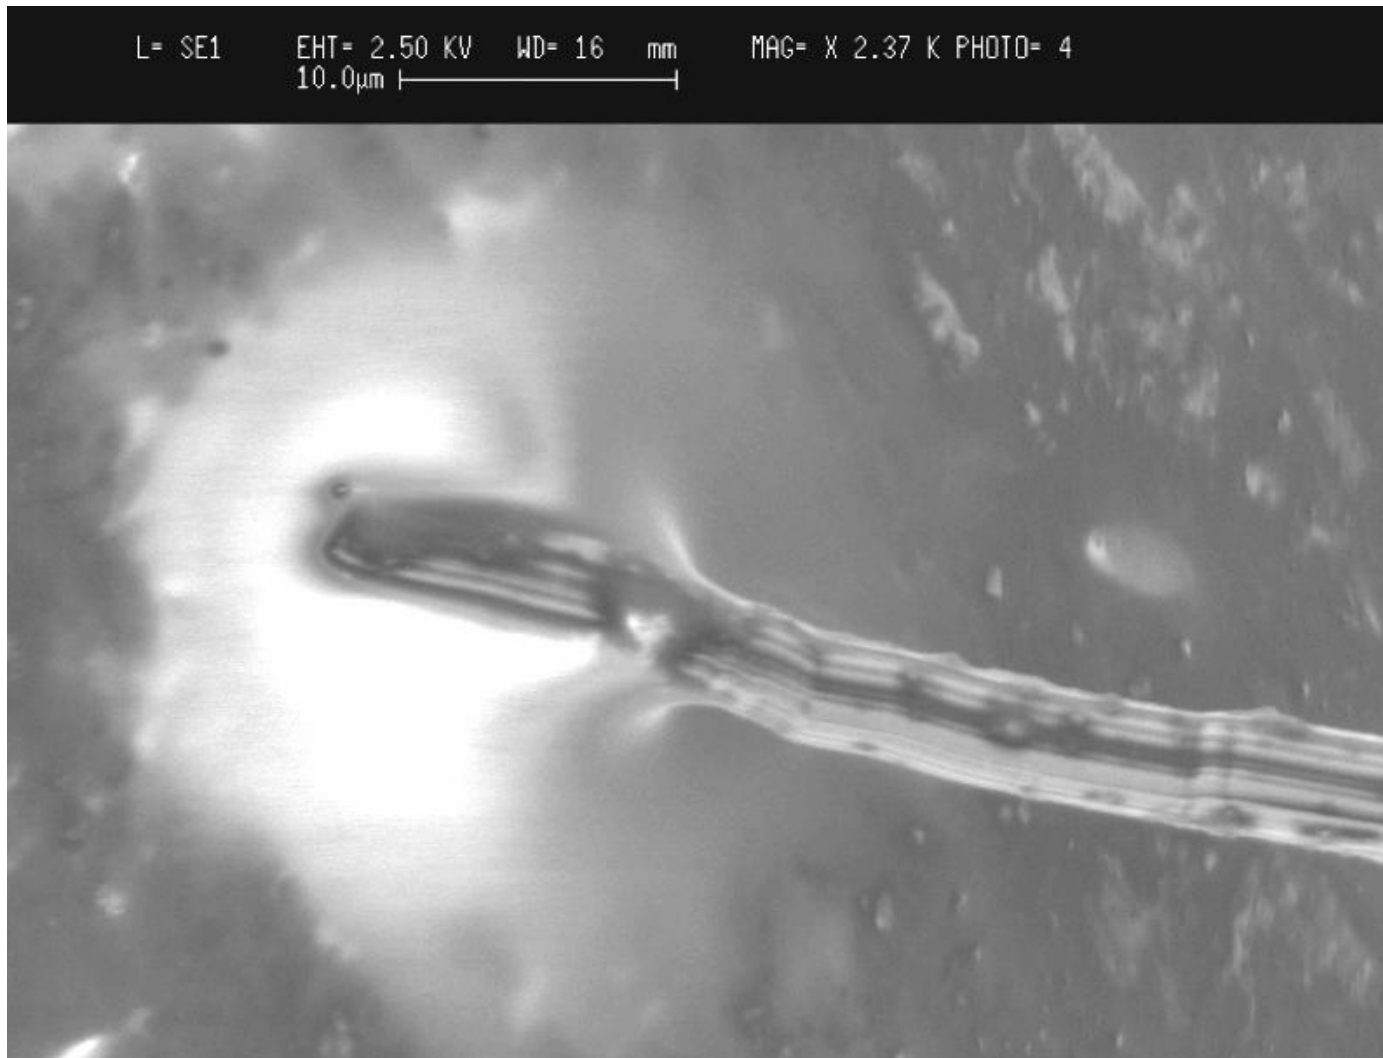
## *Whisker Shorting to Pin 1*

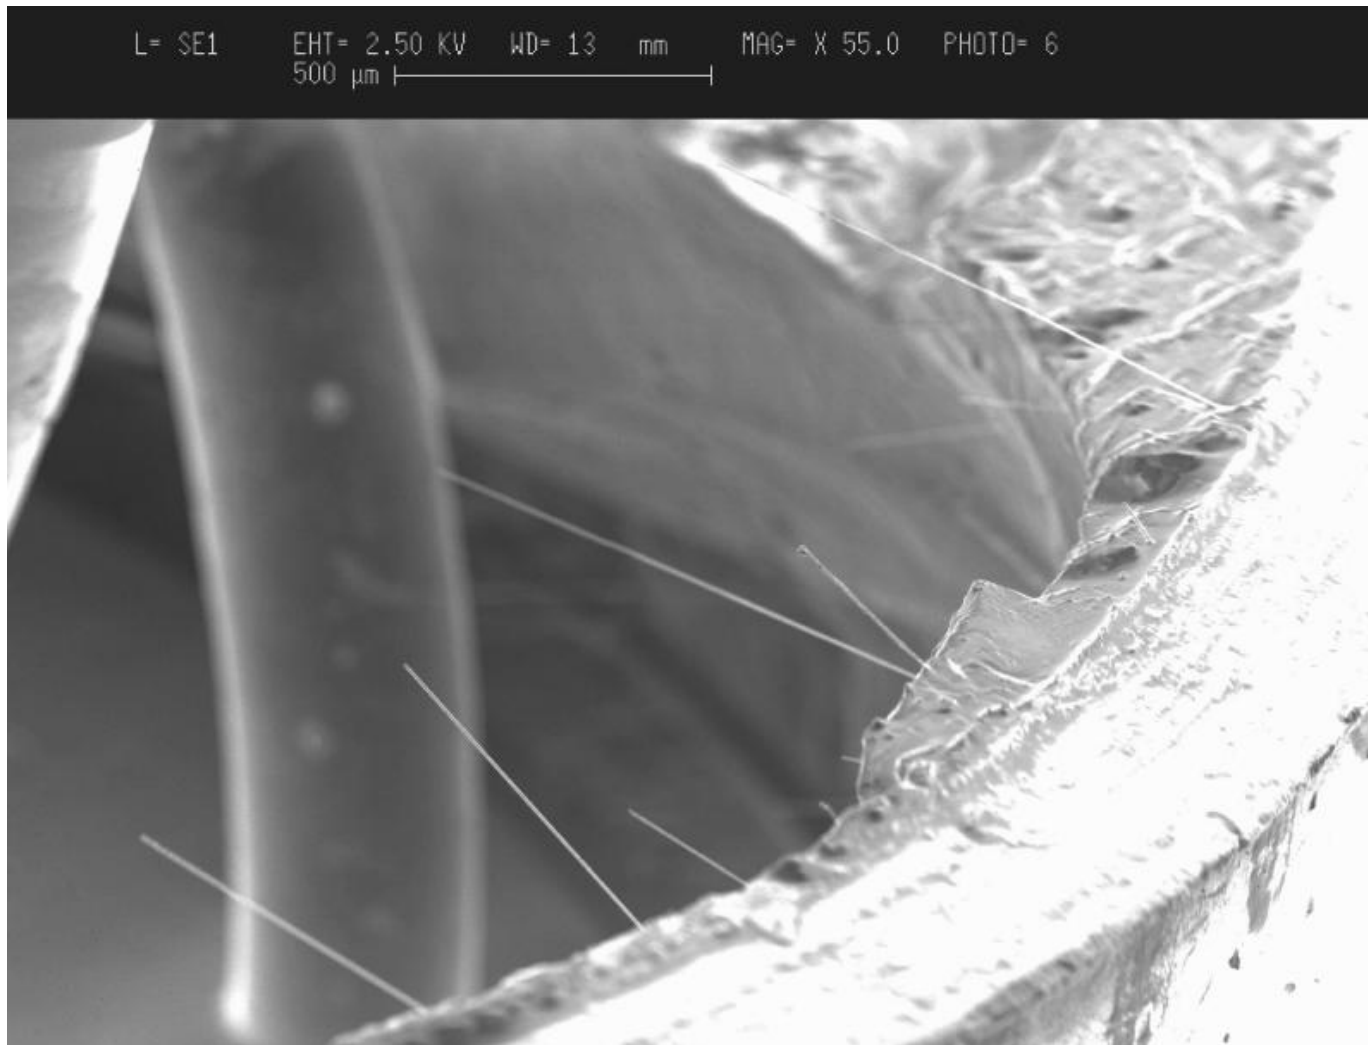
## *Whiskers Growing from Case Wall*

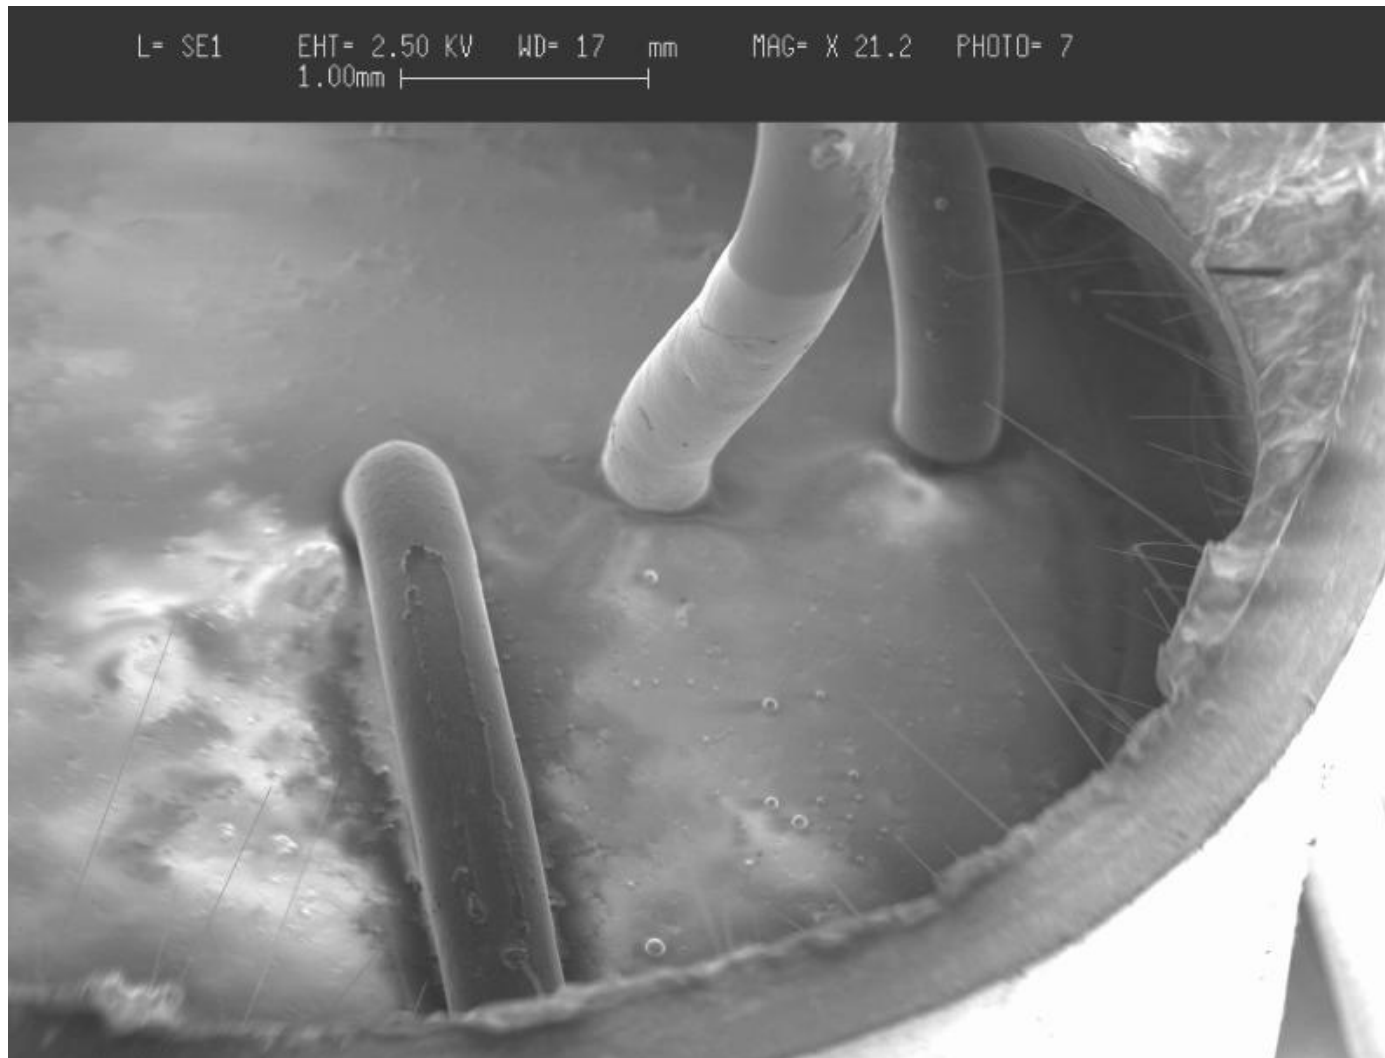
*Whiskers Growing from Case Wall Towards Internal Pins*
